Final Report for Period: 01/2011 - 06/2011

Principal Investigator: Liang, Ruifeng .

Organization: WV Univ Research Corp

SGER: Material and Structural Response of Historic Hakka Rammed Earth Structures

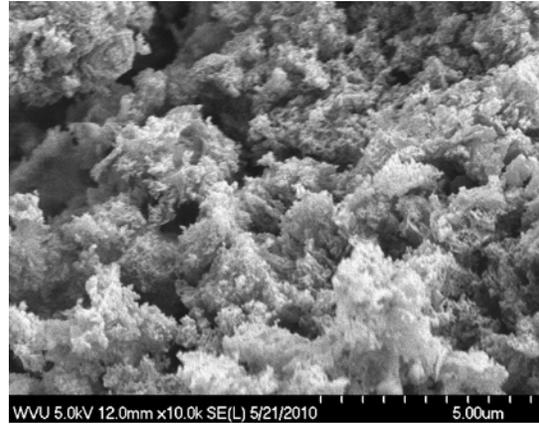
Figure 2: Fuxing Tulou earth sample SEM image

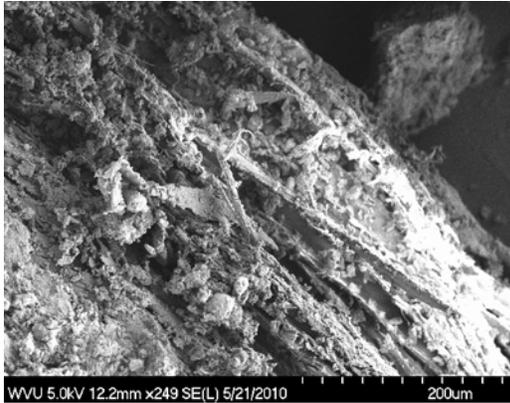
Figure 3: Wuyun Tulou earth sample SEM image showing wood fibers

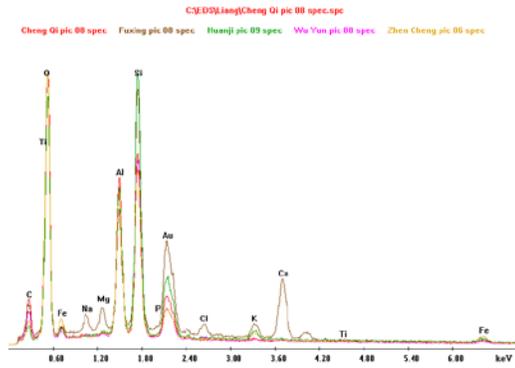
Fig. 4: Overlay EDS chart of 5 Tulou earth samples

It should be noted that the oldest Tulou, Fuxing, displays different spectrum from remaining four Tulou and shows an abundant amount of calcium while Wuyun and Chengqi have small amounts of calcium. Calcium comes in lime and subsequently is a constituent material of the walls prepared by the Hakka people. This large amount of calcium in the Fuxing Tulou earth sample explains the high strength of the walls and that the Fuxing Tulou has survived for over 1240 years.

Autogenous healing has been researched for several decades in common building materials such as concrete. Current research regarding autogenous healing of concrete has mostly portrayed the healing of small cracks or micro cracks experienced in concrete systems. The key ingredient to the autogenous healing process is lime. As cracks appear in concrete systems, water infiltrates the cracks and dissolves any lime that it may come in contact with. The dissolved lime is then taken to the surface of the crack where it carbonates and begins to heal the crack (Rhydwen, 2007). The key component to lime is calcium. However, Figure 4 EDS chart for Huanji Tulou indicates no calcium in its rammed earth.

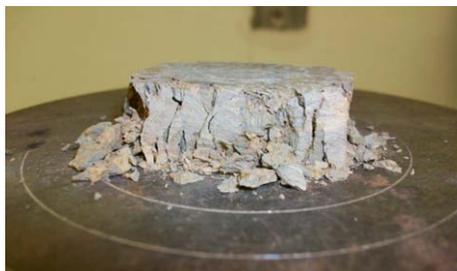
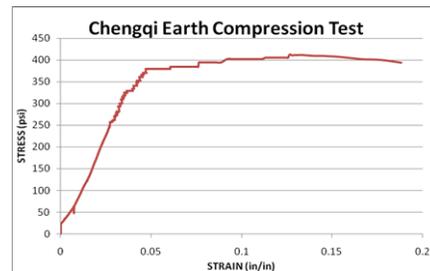
Figure 5: Chengqi earth sample after compression testing and resulting stress/strain curve

Rammed earth samples from the main wall structures of five Tulou were extracted and tested. Figure 5 shows representatively Chengqi Tulou earth sample after testing and resulting stress/strain curve. Table 2 summarizes the results of the rammed earth compression tests performed by both WVU and XMU. Note that testing of Huanji Tulou earth samples did not result in reliable property data because of their brittle nature. As shown in Table 2, it is amazing that the rammed earth sample from the oldest Fuxing Tulou has strength and stiffness equivalent to those of the younger Chengqi and Zhencheng Tulou. On contrast, the rammed earth sample from Wuyun Tulou at 500 years in-service, has the lowest strength and stiffness, likely due to prolonged weathering effects as well as the composition of the material. This, among many other factors, helps explain why part of Wuyun Tulou’s front rammed earth wall is leaning inward and currently needs structural retrofit.

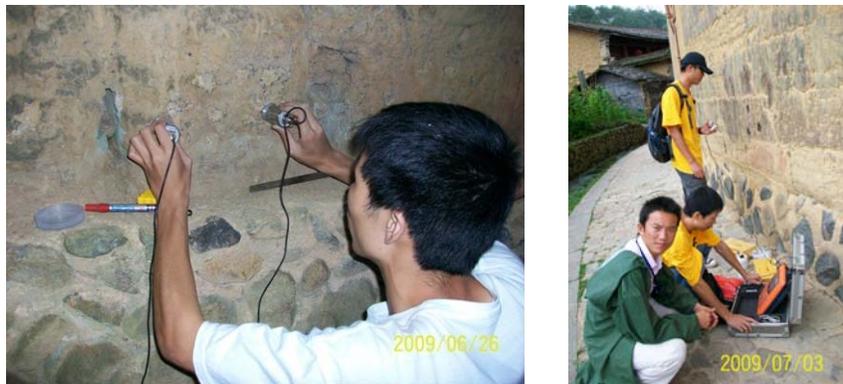
Fig 7: Ultrasonic testing heads and device

Ultrasonic testing is a NDE test which can tell us the strength of the material as well as if defects are present in the material. A wave, in this case produced by an ultrasonic transducer, will travel through a material such as the rammed earth wall and be detected by a receiver (as shown in Figure 7). The way how the wave propagates can give valuable information with respect to the structural integrity of the structure being tested. More specifically, the velocity of the wave is a function of the material's properties such as stiffness, density, and Poisson's ratio as well as the presence of defects. Similarly, the amplitude of the wave sent through a material is expected to be higher through a more "sound" material or a material that shows fewer defects. A combination of velocity and amplitude measurements provides more useful information by increasing the sensitivity of the ultrasonic technique to defects. In most cases a decrease in wave amplitude represents a possible defect. One can compare the velocity of a wave to the amplitude to see if there are inconsistencies. If inconsistencies exist then there is a possibility that a defect may be present (Halabe et al, 1995).

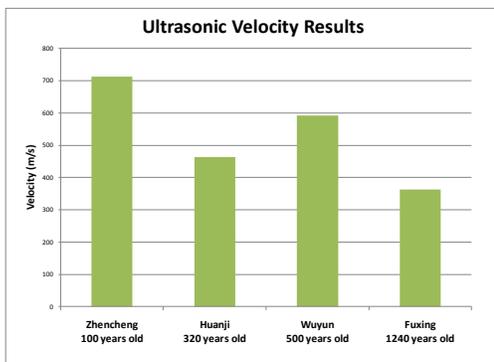
Fig 8: Ultrasonic velocity results*

*Fuxing Tulou data obtained on wet walls due to rain

Figures 8 and 9 show the ultrasonic velocity and amplitude results for the buildings tested. Both charts are consistent and show the same trend. This most likely means that no large defect exists in the areas of the material that were tested and that the readings may reflect the strength of the materials. Note that each data point represents an average of 25 to 30 measurements. As can be seen in Figs 8 and 9, apparently, there is no direct correlation between the age of the Tulou structures and the velocity/amplitude (the strength of the rammed earth walls) of the ultrasonic wave. Other than the age, there are many more parameters in the wall system varying from one Tulou to another, including different earth constituents, with or without wall ribs, and varying construction quality.

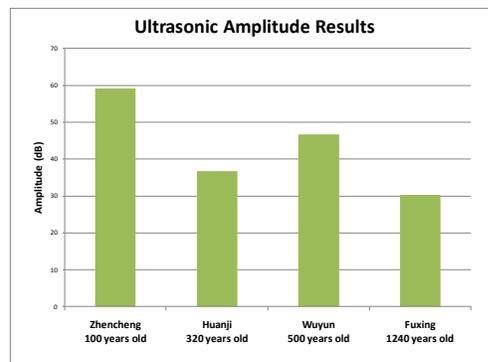
Fig 9: Ultrasonic amplitude results*

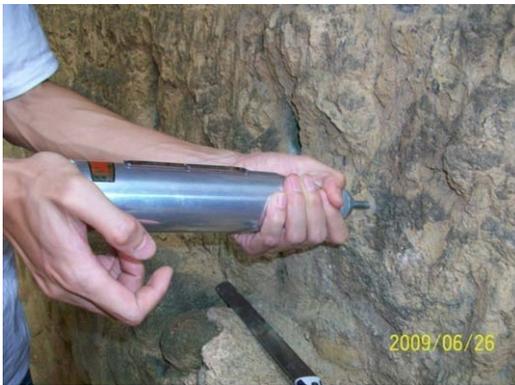
Fig 10: Rebound Hammer

As per ASTM C805, a rebound hammer works as follows: A steel hammer impacts, with a predetermined amount of energy, a steel plunger in contact with a surface of concrete, and the distance that the hammer rebounds is measured. This is shown in Figure 10. During the field study, two types of rebound hammers were used, one specifically for brick and another specifically for mortar. Figure 11 shows the results of the rebound hammer test. Note that Rebound Hammer is not designed for rammed earth wall but offers a method to quantitatively evaluate the strength of Tulou earth walls. Each data point represents an average of 32 to 64 readings in case of rebound hammer measurement. Also, all the measurements from Fuxing were conducted on wet walls because of raining weather during field study and its value was likely underestimated. In a similar manner dealing with the ultrasonic data, the discussion on the rebound number can be made with reference to the strength and modulus data of the rammed earth wall samples reported in Section 3 of this report.

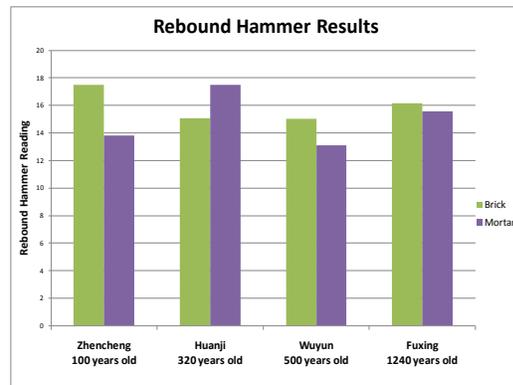
Fig 11: Rebound Hammer results

*Fuxing Tulou data obtained on wet walls due to rain

As shown in Figure 11, the average rebound hammer readings do not show any correlation between age of the Tulou and hardness of the material tested. Apparently, the brick rebound hammer represents the conditions of the rammed earth wall more accurately than the mortar rebound hammer with reference to the experimental modulus data of the rammed earth walls. According to the brick rebound hammer values, the Zhencheng would have the highest modulus of the elasticity, followed by Fuxing, and the Wuyun and Huanji would have similar low modulus values. Except for Huanji where the mortar rebound hammer average reading was much higher than the brick rebound hammer, for other Tulou, the brick rebound hammer always gave higher average reading than the mortar rebound hammer. Note that each value is a statistical average over a number of measurements.

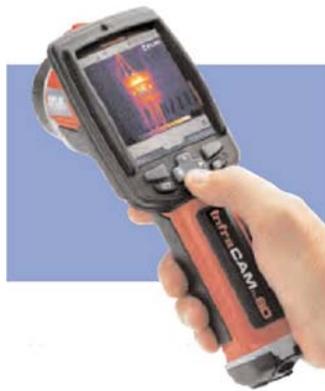
Fig 12: Portable IRT camera used

Infrared thermography (IRT) is a viable NDE method potentially capable of scanning a large area of testing structure and detecting subsurface delaminations and debonding between the surface layer and the substrate. This technique is based on the principle that subsurface defects and delaminations affect the overall thermal conductivity of the material, leading to different rates of heat transfer through sound and defective regions and thus, surface temperature differentials. For the present study, a brand new portable IRT camera model InfraCAM SD Camera was purchased (shown in Figure 12) and brought to China for field studies.

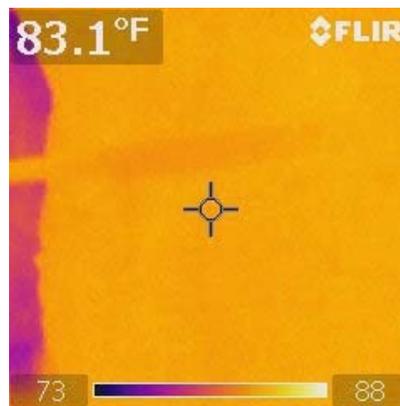
Fig 13: IRT detecting shallow wall rib

IRT camera was intended to perform a couple of functions upon verification of its usefulness during field study. One function would be to identify the presence of a wall rib with reference to a wall without wall ribs. If successful, we would be able to quantify the spacing, pattern, size and total volume of wood or bamboo wall ribs used as reinforcement within the rammed earth walls. Unfortunately, it was found that the IRT was not sensitive enough to detect the difference in the heat transfer rate between the walls with or without wall ribs. This is because the constituent materials to build a rammed wall, including earth, wood, bamboo, stone and others are all natural materials. Under a normal condition, they are all thermally in equilibrium. The surface temperature difference between the walls with or without wall ribs is almost zero, especially when the wall ribs are embedded in depth away from the wall surface and the wall has a thickness of 1.5 to 2 meter. Note that IRT is only able to identify defects under subsurface (at a limited depth). For example, the IRT is indeed able to detect the wall rib as shown in Figure 13 where a slightly dark shadow represents the wall rib, when the wall is around 12" in thickness with a crack in the vicinity. Due to crack, wind effects and shallow embedment of the rib in the wall, the temperature difference

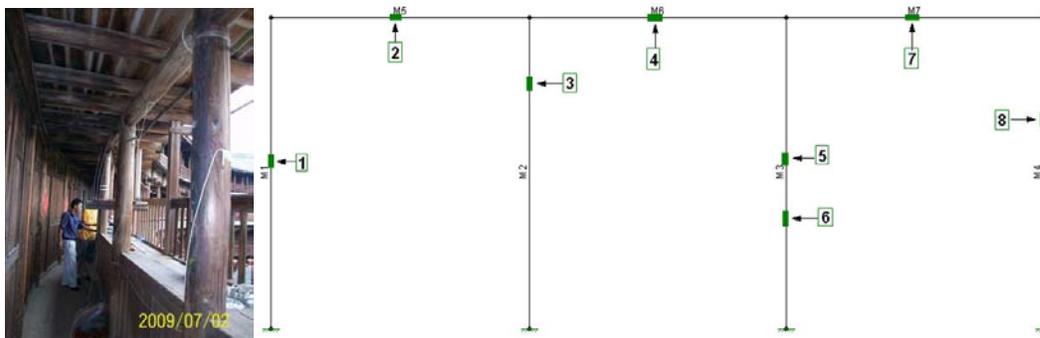
Fig 15: Load testing of floor system, member definition and strain gage locations

The floor system of Chengqi Tulou was tested by means of a two point load of up to 550 lbs. The test section of the floor is shown in Figure 15 along with a schematic illustration where each member is assigned with a number (M1 to M7) and strain gage locations are indicated. The load was applied onto Beam M6 between Column M2 and Column M3 as two equal concentrated loads symmetrically placed.

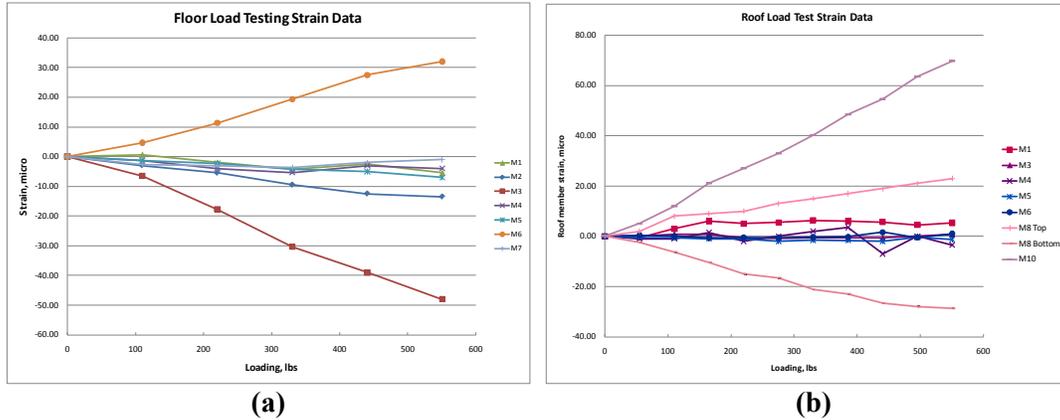
Fig 16: Strain data from load tests, a) floor system member strain data; b) roof truss member strain data

The strain data generated from the floor testing are graphically shown in Figure 16a, in terms of the strain gage locations and corresponding structural members as defined in Figure 15. The strain was recorded as a function of loadings for each member. Each strain value at a given loading was an average of three measurements from three separate runs. The load applying member M6 (gage #4) behaved as expected and gave a strain of 32 microstrain under maximal loading of 550 lbs. All other members had small strain values except the vertical member M3 (gage #5) that had unusual much higher values and gave a strain of 48 microstrain under 550 lbs.

The strain data generated from the roof truss structure testing are graphically shown in Figure 16b, as per the strain gage locations and corresponding structural members as defined in Figure 17. Similarly, the strain value was recorded as a function of loadings for each member mounted with strain gage. Each strain value at a given loading was an average of three measurements from three separate runs except that Member M4 (gage #8) had only two sets of data to average while the third set of data were mostly positive, resulting in uncertain trend for Member M4. It is not sure if this unclear trend was attributed to disturbance during testing or structural sensitivity. Note that the strain gages used were all 5 cm long gages to maximize the ability of detecting any small strains. All other members except M4 behaved as expected. The load applying member M10 (gage #4) gave a strain of 70 microstrain under maximal loading of 550 lbs. For M8, the bottom side was subjected to compression (negative strain) and the strain values were closely matching those of the top tension side.

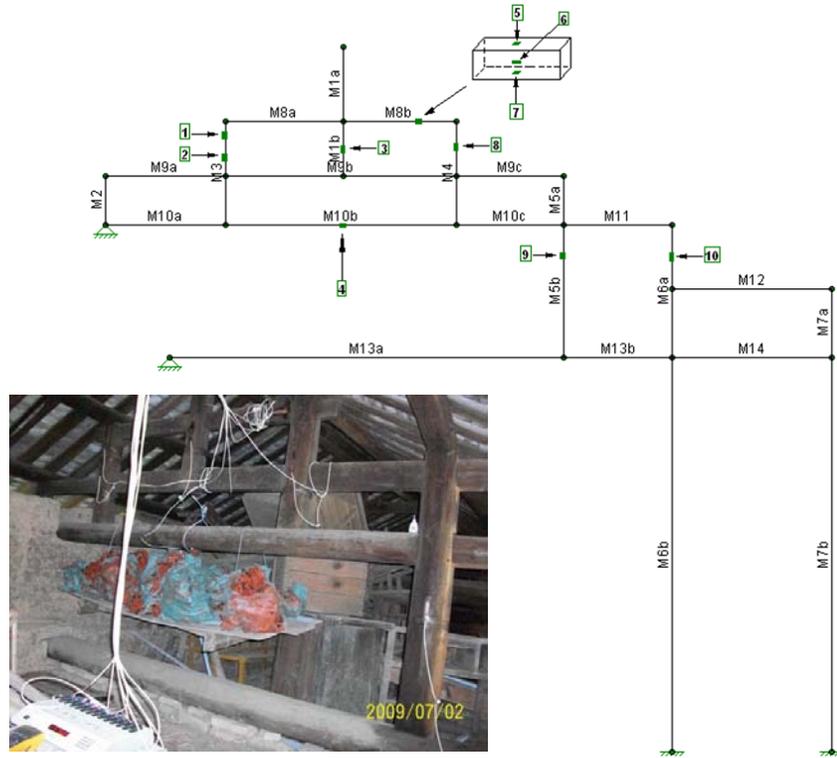
Fig 17: Load testing of Tulou roof truss, truss member definition and strain gage locations

The roof truss structure is much more complicated as compared to the floor system and is shown in Figure 17. The roof truss system consists of a group of horizontal members and vertical members, with each being connected to another through pinned connection. The roof truss load testing was also conducted at Chengqi Tulou by means of a two point loading of up to 550 lbs. The load was applied onto a horizontal beam with the largest span while several vertical members were attached to this beam, which support roof beams. Figure 17 shows a photo of the major sections of the roof truss structure being evaluated while the entire roof truss structure is schematically illustrated where each member is assigned with a number (M1 to M14) and strain gage locations are indicated with reference to mounting member. More specifically, the load was applied onto Beam M10 between Columns M3 and M4.

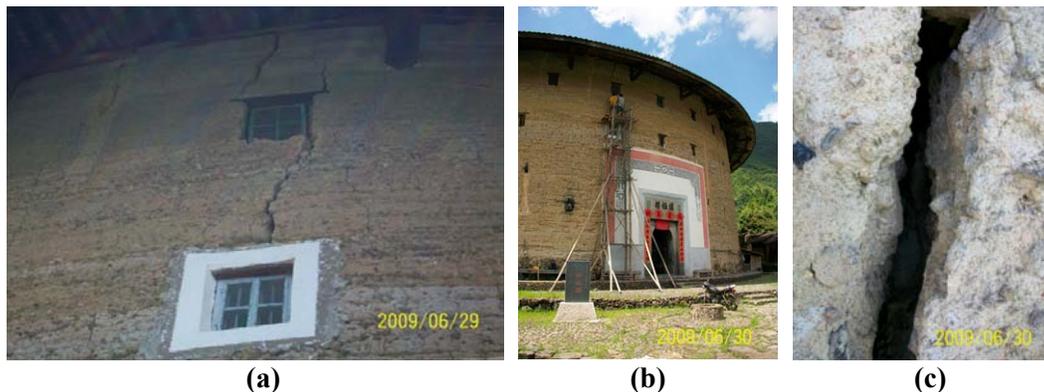
Figure 18: Huanji Tulou wall crack after earthquake, a) a global view of the crack, b) the crack location with reference to the ground and the access platform used during field study, c) close view of the crack

Huanji Tulou has an O/D 43.2m and 20m in height. It was reported that there was a 3m long crack of 20 cm in width due to a strong earthquake in 1918 that was self-healed after quake. As a matter of fact, the large crack is still on the wall. The reported earthquake-induced crack is about 10 meter above the ground. A global view of this crack is shown in Figure 18a. The crack begins from the 3rd floor window, across the 4th floor window and thru the top edge of rammed earth. To access and examine the crack, a construction worker was hired to build an access platform using bamboo during the field study in the summer of 2009, as shown in Figure 18b. After measuring the crack, including use of a laser distancer to measure its depth, the researchers found that the crack was about 350 cm in height including the crack thru the 4th floor window, with the crack between 4th floor window and 3rd floor window being the worst. That section was 178 cm in height, 5 to 10 cm in width, and 93 cm in depth. As shown in Figure 18c, this crack was actually across the entire wall thickness and most surprisingly, there were no wall ribs at all inside the rammed earth wall.

If in fact the crack was originally 20 cm in width as initially reported, there could be some kind of self-healing process that should possibly be explained scientifically. In order to further analyze the structural behavior of the Hakka Tulou buildings, FE modeling was used to duplicate the structural behavior experienced in real world conditions (Stanislowski, 2011). A 3D model was built using the modulus of elasticity values reported in Table 2 as well as actual dimensions of the Huanji Tulou. The modulus of elasticity used was taken from Wuyun Tulou samples as this value is most conservative and no property data available for the earth samples from the Huanji Tulou. Also included in the model is the reported 20 cm wide crack that is 3 meters in length.

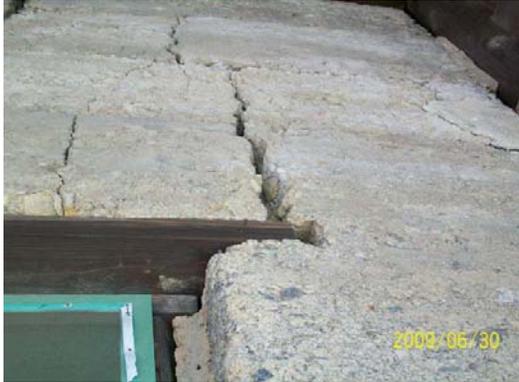
Figure 19: The crack and cavity at lintel end

Considering the scale of this crack, we would like to doubt if there was such story-telling self-healing. One observation from our close-examination of the crack can be drawn from Figure 19. It was noticed that there is a 5 cm cavity at lintel end. If the wall would have self-healed 5 cm, that cavity and most of the crack would disappear. Hence, we would like to interpret the fame of Huanji Tulou as the strongest Tulou as follows: Even though Huanji Tulou had such a large cross-thickness crack, it is still structurally sound. Why the crack occurred with Huanji Tulou is most likely because it does not have reinforcing wall ribs in its rammed earth wall.

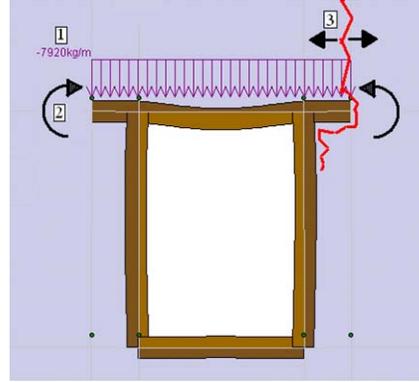
Figure 20: Lintel behavior

The crack at the Huanji Tulou reportedly occurred due to a strong earthquake that hit the region. The crack began at the end of a window lintel due to high stress concentrations occurring from bending of the upper portion of the lintel. Why and where exactly the crack formed (Figure 19) has been accurately modeled using FE analysis, based on Lintel behavior as shown in Figure 20 along with an earthquake load, using the material property data generated from this study (Table 2 and Table 3). Figure 21 is a chart illustrating the stress in vertical direction upon application of a 220 kips horizontal load induced by an earthquake. Details can be found in (Stanislowski, 2011). Through the FE modeling one can see exactly how an earthquake load can cause increased loading in the Tulou and in return cause higher stresses leading to potential cracking. The FE modeling further demonstrated that if the rammed earth wall of Huanji Tulou were reinforced with wall ribs, such cracking could be totally avoided. Cracking could have also been avoided by using a stiffer lintel. This might explain why other Hakka Tulous in the area survived from the earthquake even without cracking.

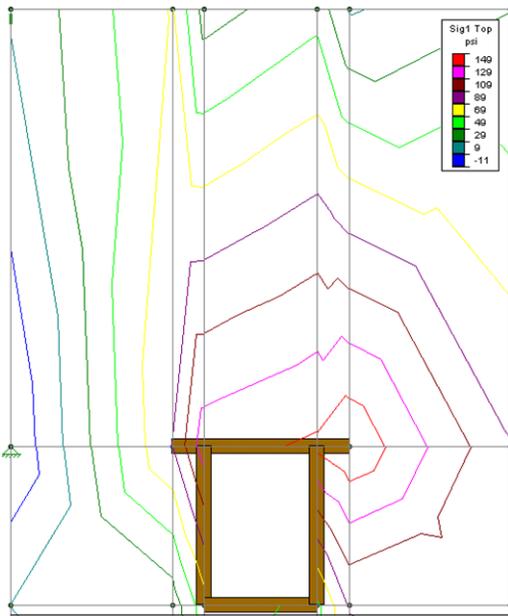
Figure 21: Stress in vertical direction due to horizontal load induced by Earthquake

Stress analysis was performed using the maximum principle stress theory. This theory states that the material will yield when any of the principle stresses reaches the yielding stress (Benham and Warnock, 1973). Through numerous testing it has been found that the maximum stress theory works best for predicting failure in brittle materials such as concrete, cast-iron, and ceramics (Benham and Warnock, 1973). As rammed earth is a brittle material, analysis of the material will be performed using this maximum stress theory. Figure 11 shows the stress distribution on the model Tulou integrated with wooden structures after applying the lateral forces to each floor. The stress distribution in Figure 11 shows the stress, σ_1 , which is the stress in the vertical direction of the wall. The σ_2 distribution is simply a mirror image of the σ_1 stress distribution.

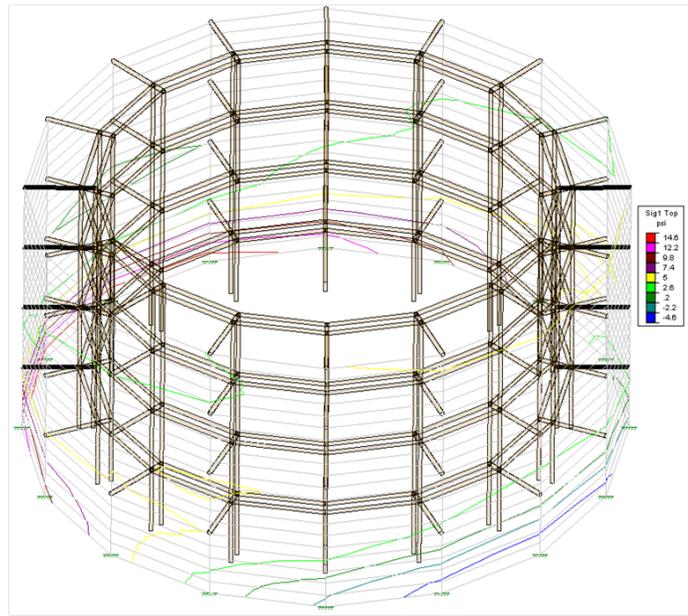
Fig 22: 3D Earthquake stress distribution of Huanji Tulou with inner wooden systems

structures), the maximum stress is 141 psi near the base of the Tulou. These models and results are conservative as the lowest modulus of elasticity of 1705.5 psi was chosen from all rammed earth samples tested. Realistically however, since the Huanji Tulou is one of the younger Tulou structures at 300 years of age the modulus of elasticity of the rammed earth is most likely to be higher and thus ultimate strength is most likely to be higher as well. If one is to analyze the stress data above and compare the data to ultimate strength values that range from 126 psi to 411 psi as found in compression testing (Table 2), one can see that the strength of the rammed earth walls is 9 to 28 times higher than the maximum value of 14.6 psi from the modeling. Failure would not be expected even at/near the base of the structure where the maximum tension and compression stresses occur as predicted by the model. It is important to note that only ultimate compressive strengths are known for the rammed earth and that tensile strength of such materials is surely lower than its compressive strength, for this reason the structure would fail in tension at the base, sooner than it would in compression, if the earthquake induced stresses were equivalent to the ultimate tension strengths of rammed earth walls. It should also be noted that many rammed earth walls are reinforced with wood chips and as discussed at Section 3.4, those wall ribs greatly enhance the earth walls.
